# Diagnosing and resolving DSM issues

From: <https://rmtechserv.vm.bytemark.co.uk/wiki/> - Raymarine Product Support Wiki

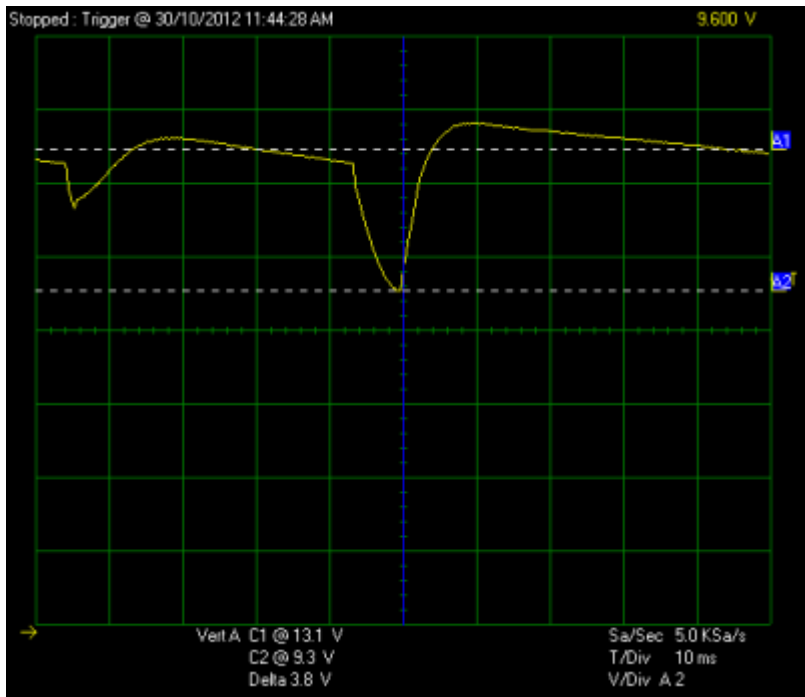
Two DSM300 charge cycles. Taken on a large, new, 24V powerboat, with engines running and batteries at 27V, that was using a DSM30 powered via a 25A 24-12V convertor from a reputable brand. Voltage scale: 2V/div, Time scale: 10ms/div.

When measured with a good-quality digital multimeter, the power supply appeared stable at 13.7V, and under normal circumstances one would dismiss power supply as the cause of the issue. Note the duration of the supply dips (<20ms) and depth (~9V!).

**whilst the system is under load.** Ideally this should be done by an experienced Raymarine Service Dealer, using a portable oscilloscope connected to the internal power supply connections whilst the DSM is in use. **Do not** attempt to access the internals of the DSM yourself, since dangerous high voltages are present inside.

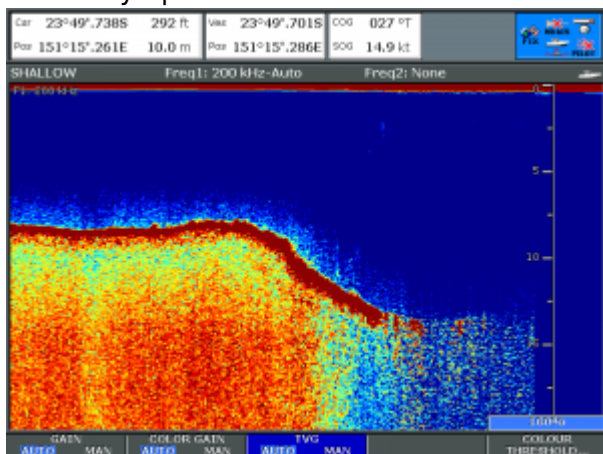
A DSM300 in Auto on a Luhrs 31 IPS, as speed increases. Note how unhelpful Auto is in gauging the cause of the fault.

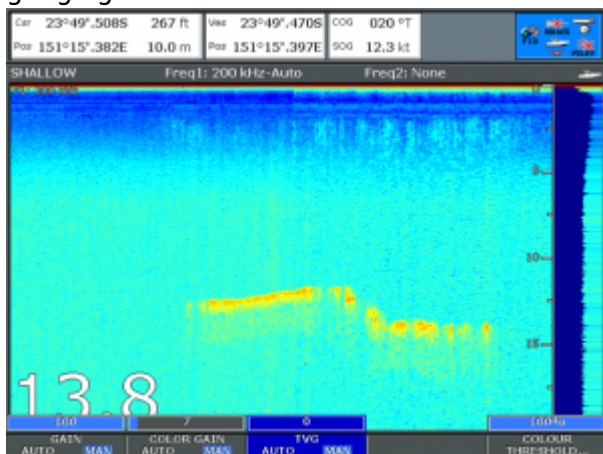
The same Luhrs 31 at higher speeds, in Manual Gain. Note the very weak bottom return, and apparently low noise level though it is hard to tell since the customer took this screenshot on CG=8 so is not directly comparable with other screenshots. This is very characteristic of aeration problems

- moving the transducer
- switching to a faired through-hull version instead of low-profile, in-hull or transom

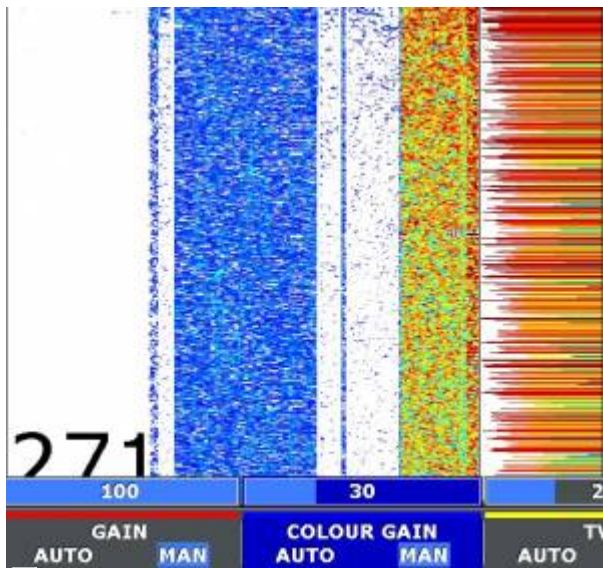
An example of measuring the background noise level. This example shows a good range of noise signal levels (colours), which generally indicates 'natural' noise

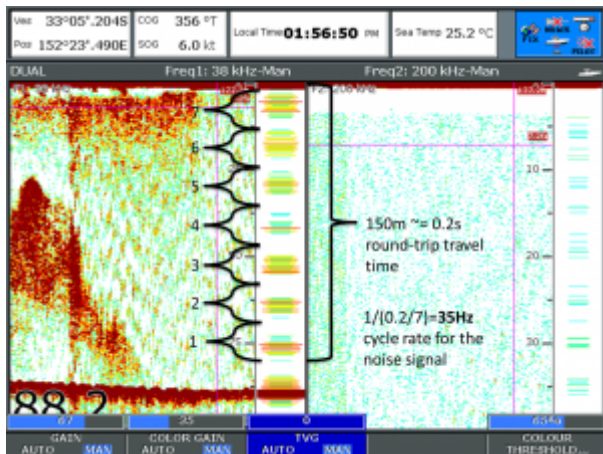
Driven noise at ~38kHz (not present at 200kHz). Note the pulsing in the A-scope view.

$$1/((150*2/1500)/7) = 35\text{Hz}$$

Given that the screenshot was taken at 6 knots, the source here could conceivably be engine noise (38Hz = 2100rpm.)

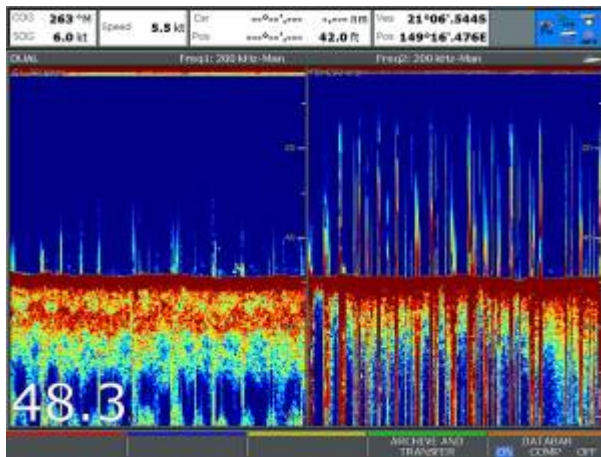
The most likely path for interference to get from pilot into sounder is via pilot drive current modulating the sounder's power supply. However, in this case the path was via radiated RF directly onto the transducer cable. The pilot drive unit was a Seastar DC Power Steering system auxilliary pilot pump, which according to Seastar was faulty and was clearly a major EMC fail. Seastar replaced the pump motor free of charge. Grounding the DSM and pump, fitting ferrites and re-routing transducer

Autopilot-sourced electrical interference on a DSM400 in Auto gain

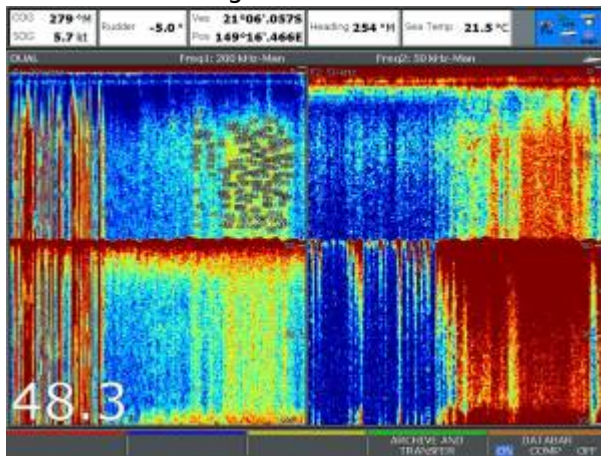
Autopilot-sourced electrical interference on a DSM400 in Manual gain (Auto TVG)

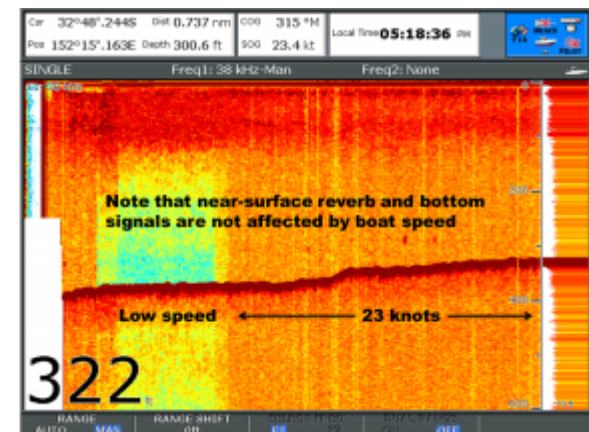
Speed-related noise on a DSM400. Note the large variation in background noise level, with effect on the signal levels, as speed increases. This is not aeration.

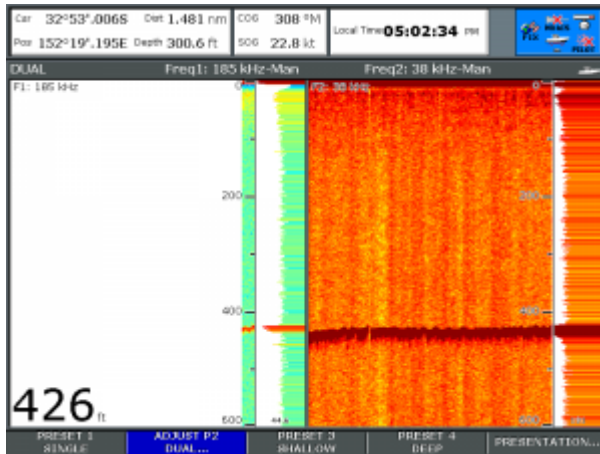
Frequency-specific speed-related noise. 38kHz is badly affected, 200kHz is not.

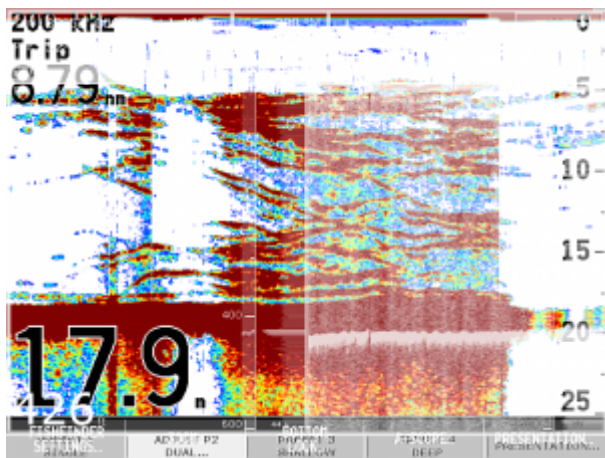
An example of bait-school lockup on A65 in all-Auto settings.

1. Switch to Manual Range: this will force the sounder to stop changing pulsewidth and pulse-repetition frequency (PRF) when it runs over a dense bait school
2. Switch to Manual Gain and Colour Gain (you probably don't need to touch TVG now): this will prevent the sounder from changing gain controls depending on what it thinks is the bottom.

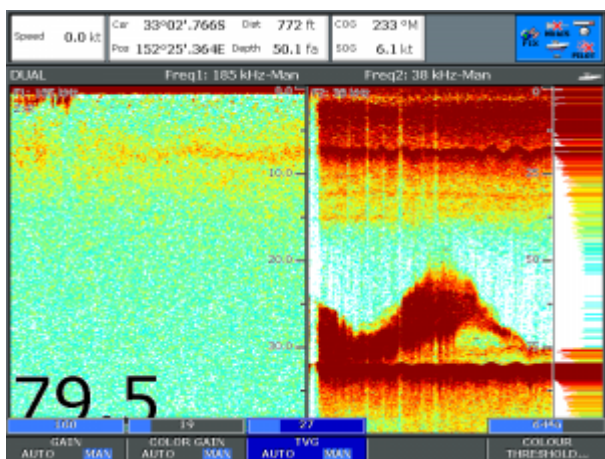
A DSM400 off Port Stephens, NSW, showing a large bait school, almost certain marlin around/in the bait, and a very strong reverb signal in the upper water layers.
