# Diagnosing and resolving DSM issues

From: <https://rmtechserv.vm.bytemark.co.uk/wiki/> - Raymarine Product Support Wiki

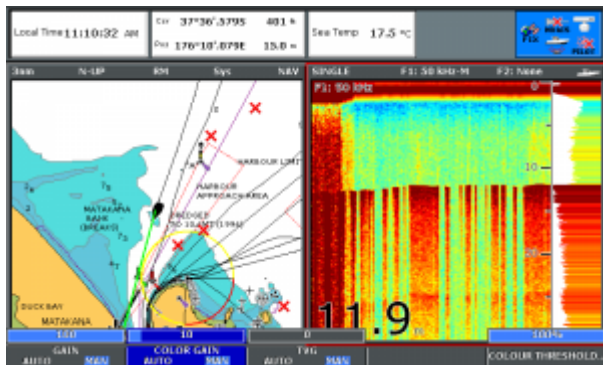
can all cause air to intervene between the bottom and the transducer face.

Air attenuates the two-way sound propagation, so causes an interruption in the sounder image.

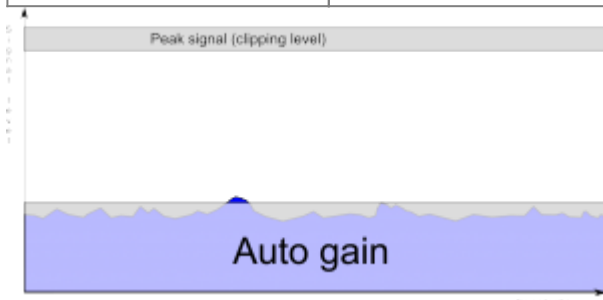
A cartoon view of Auto Gain handling a low signal level with low background noise. Note that the 'real' signal is only just above the

noise, and that this is likely to only intermittently display on-screen.

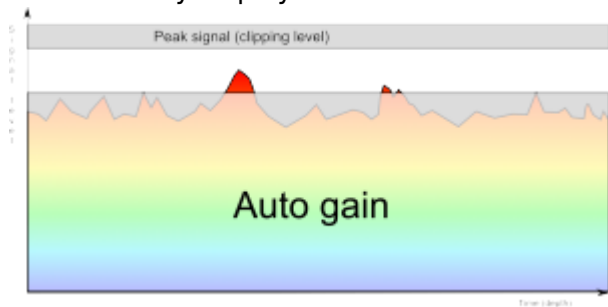
A cartoon view of Auto Gain handling a high signal level with high background noise. Note that to hide the noise, the DSM drops gain such that the 'real' signal will hardly show.

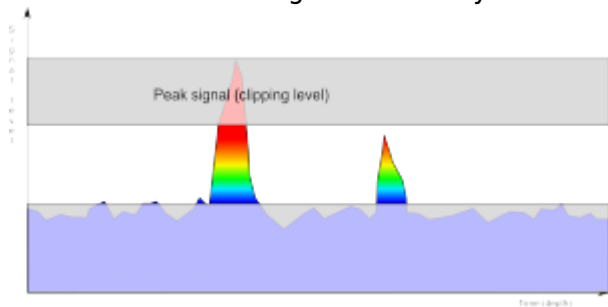
By comparison, this image shows approximately how the sounder will handle an 'ideal' situation, with strong signals and comparatively low noise levels.

As you can see from the diagrammatic views, in Auto Gain the sounder will adjust Gain, Colour Gain and TVG in order to try to hide any clutter and if the desired signals are only a little stronger, will hide these too.

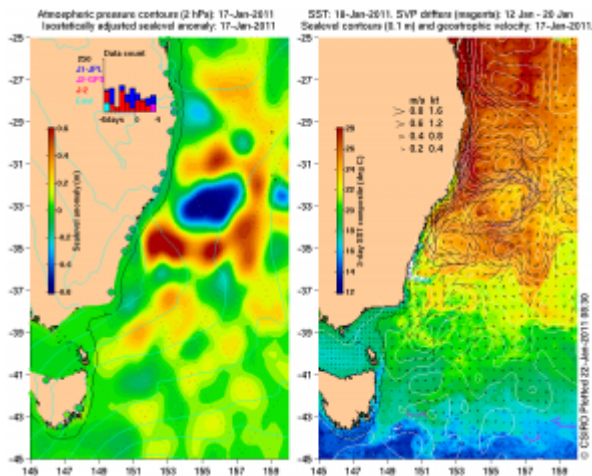
EAC current mixing off the NSW coast, 22nd January 2011
